UNDERPINNING ANCHORING REPORT

A CASE HISTORY

Project: Wall Repair,
Peterson Farms

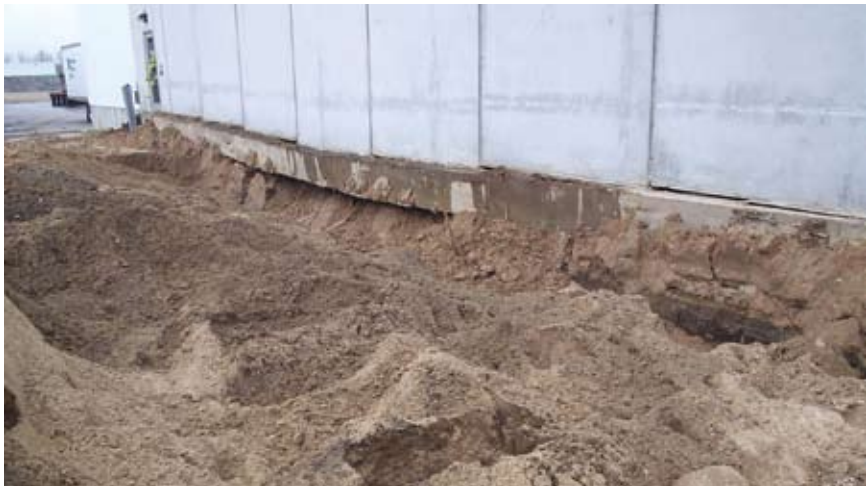
Regrading along a 200 ft. side of a tilt-up-wall building resulted in undercutting the grade beam by as much as 2 ft. In less than one day, the grade beam, wall, and roof dropped in places as much as 14" and slid out horizontally as much as 6".

Above, building condition upon arrival at the jobsite

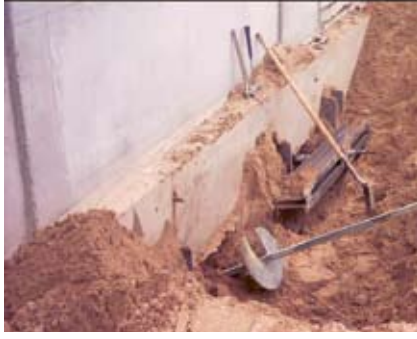
Torealign beam, 38 CHANCE® helical tieback anchors were installed between Atlas Resistance® piers.

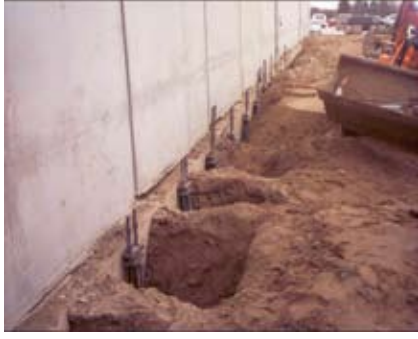
With wall elevation restored and beam straightened, pier holes were filled to final grade.

The wall was lifted and the grade beam was moved laterally to near their original positions.
